Assessment of Dam Safety

Coal Combustion Surface Impoundments (Task 3)

Final Report

JM Stuart Station

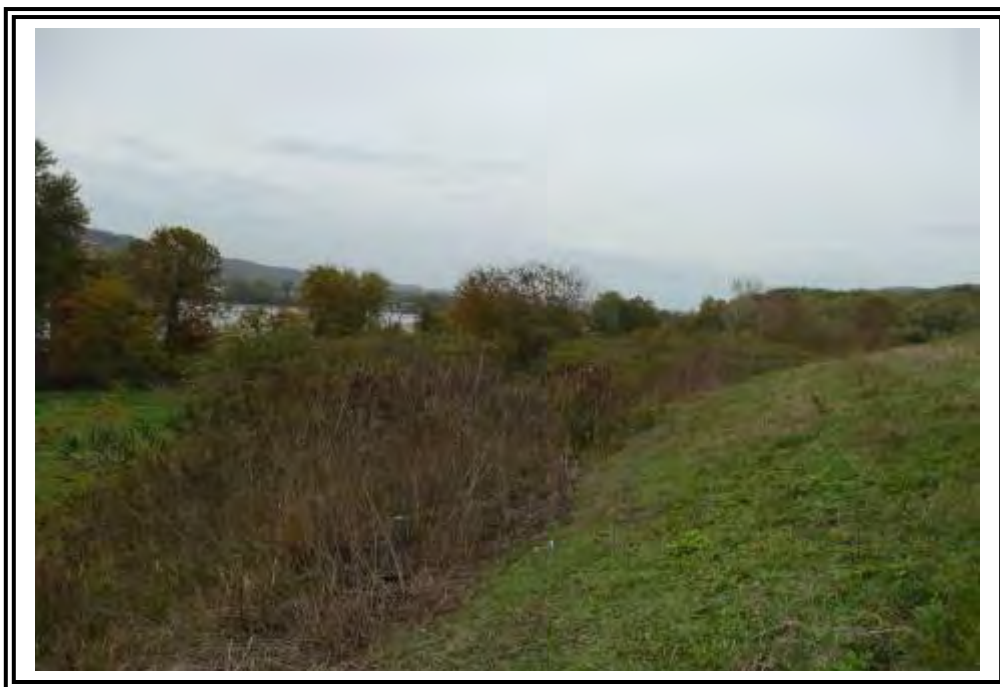
11

Heavier vegetation noted in area of seep on southwest end of pond.

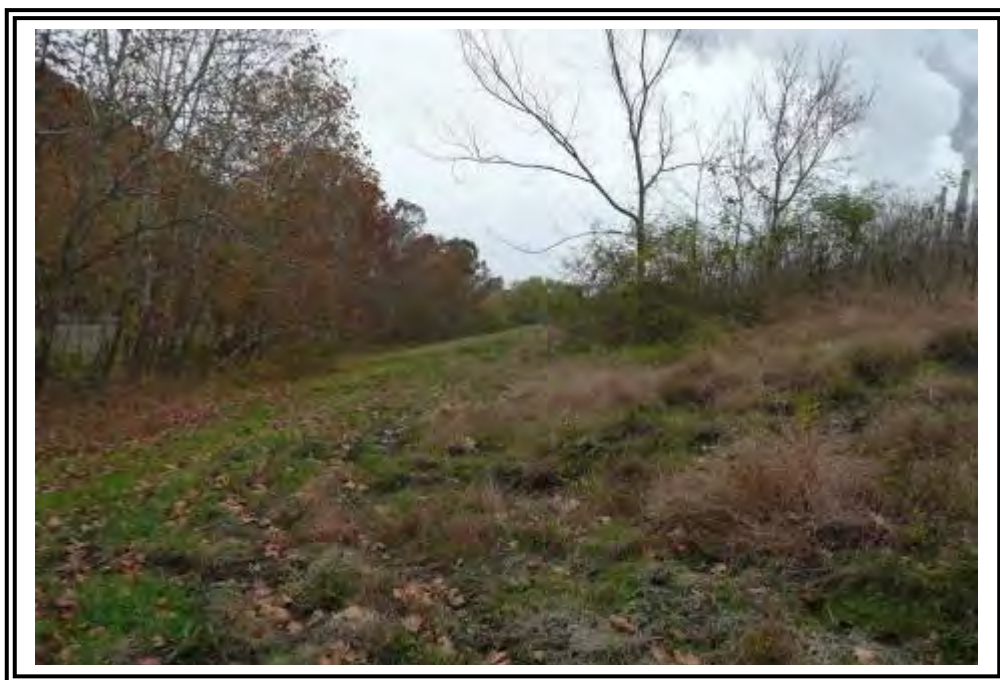
12

Another view of heavier vegetation and slope deformation in seep area at west end of pond.

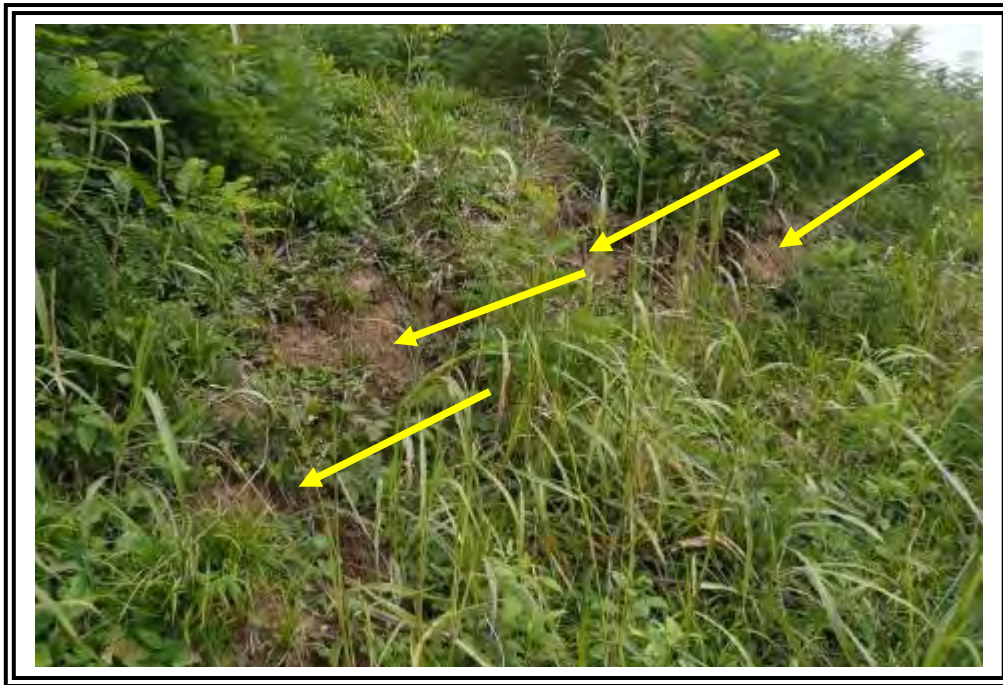
13

In addition to the seeps and resulting softened slope areas, scarp areas were observed on the south side of the pond and western extremity of the pond. A scarp on the south dike (Photo 13) occurred along a heavily vegetated, over-steepened portion of the dike adjacent to a haul road drainage ditch. It measured roughly 52 feet in length along the dike centerline. The scarp encountered on the west end of the pond measured approximately 30 feet in length and appeared to occur in a location of softer soil (Photo 14). Standing water was observed in this scarp and the soft soil in the area of the scarp is likely the result of seepage at this location.

Partially vegetated scarp in heavily vegetated, steeper slope on south side of the pond.
Approximately 52 feet long. (See arrows)

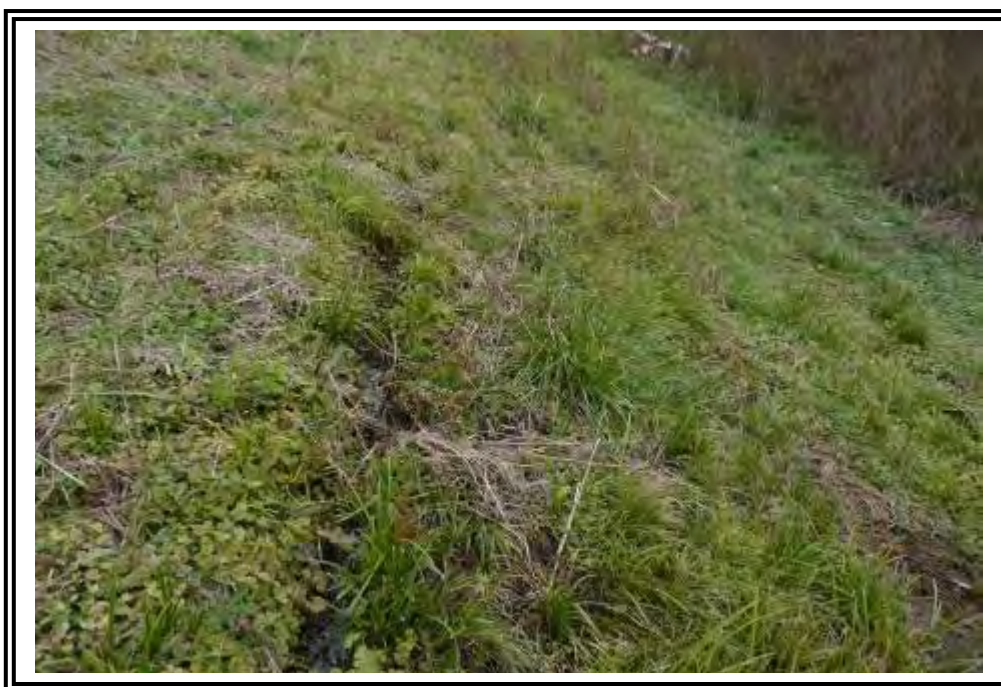
15

Close up of a rut with standing seep water.

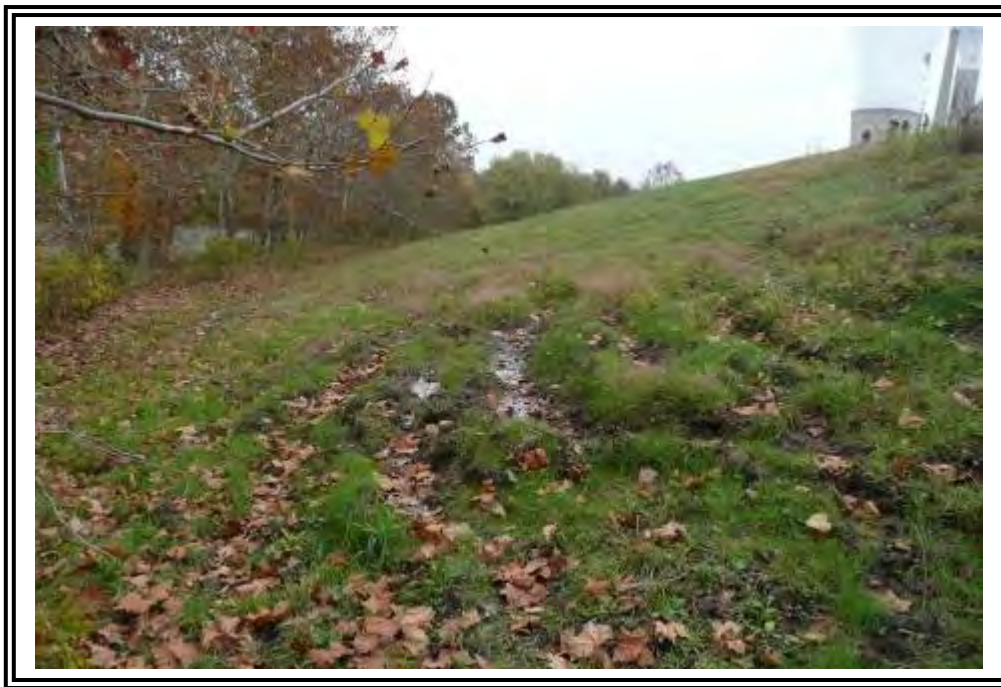
In general, the south dike (Photo 6) and the north dike (Photos 20 and 21) appeared to be maintained and mowed. However, seepage initiated slope softening and subsequent mowing induced rutting and slope deformation was observed on the downstream slopes of the dikes in at least four locations. One such area measured approximately 326 feet long approximately 52 feet from the toe with 6 to 12 inches of standing water (Photos 15 and 16). These areas often had heavier vegetation, scrub brush, and small trees established where routine tractor mounted mowing had not occurred for a fairly long period of time as a consequence of the softened slope conditions (Photos 11 and 12). In most cases however, these areas were generally covered with heavier grass and other weedy vegetation (Photos 10, 19 and 22).

Looking east along the downstream slope of the northern dike.
Notice the taller grass and rutting with standing seep water.

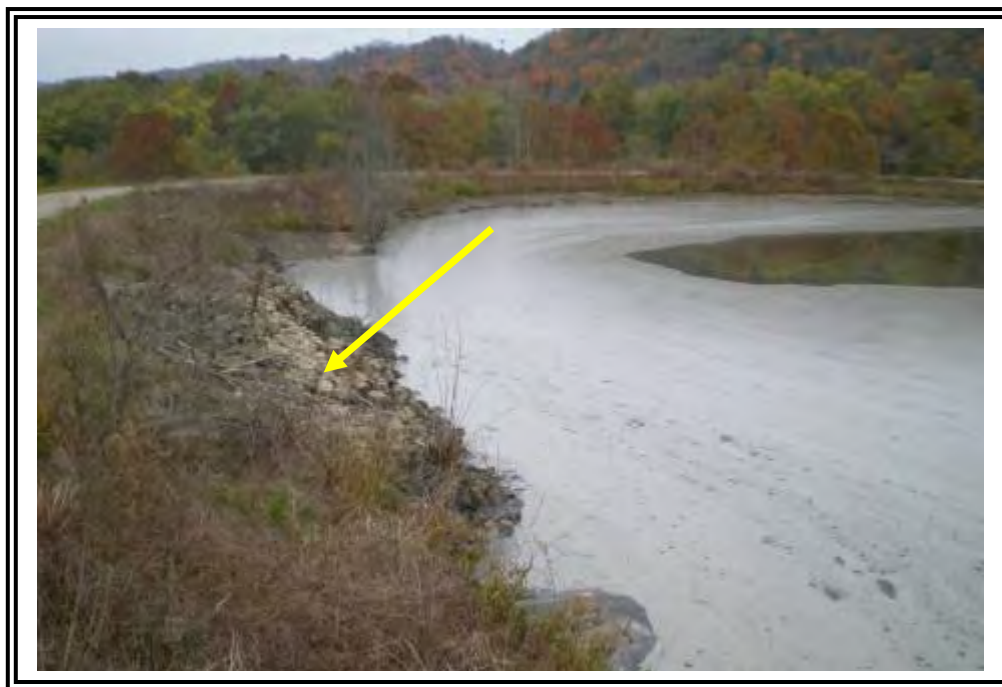
23

Looking west along upstream slope of the southern dike at west end of the pond showing moderate vegetation. Isolated riprap area is visible in this photo (see arrow).

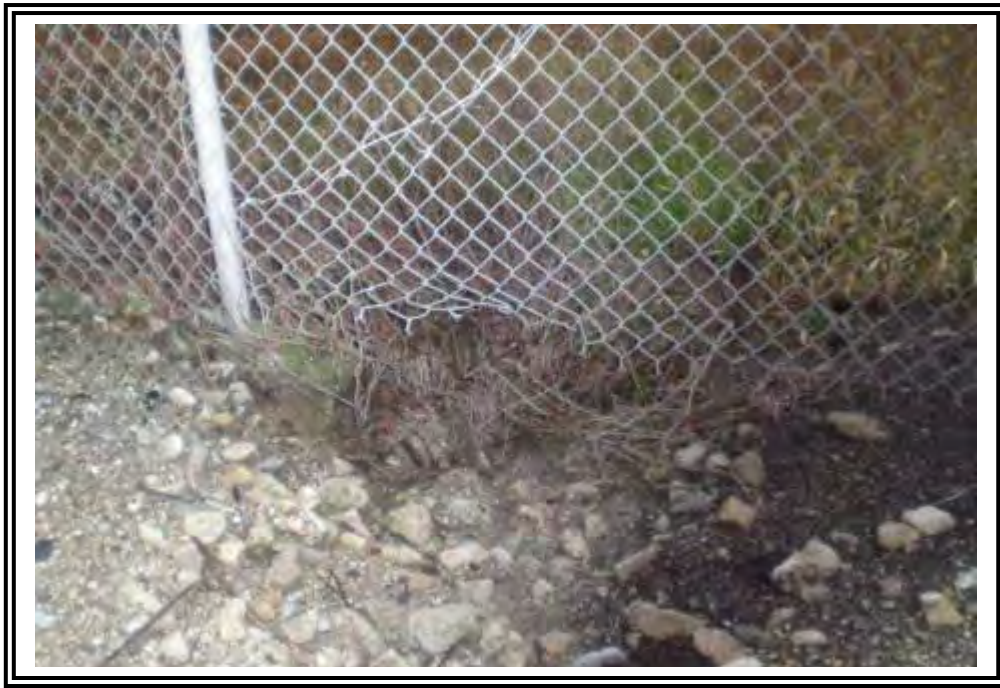
41

Close up of erosion at edge of crest under the fence on the west dike of pond.

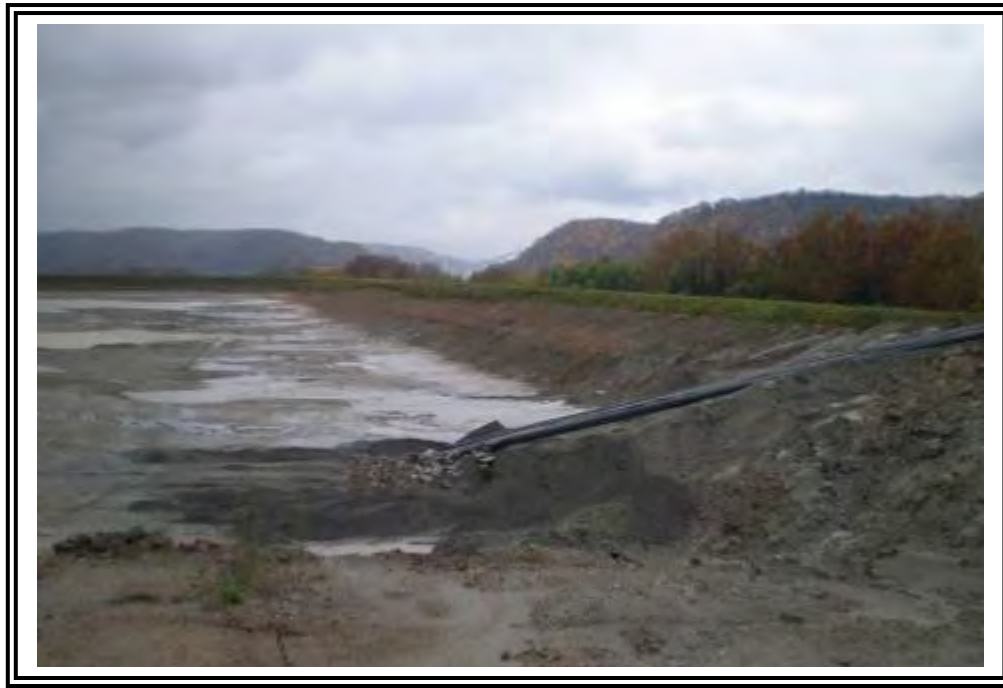
45

Looking east along the upstream slope of the south dike.
There was very little grass cover due to summer dredging activities.

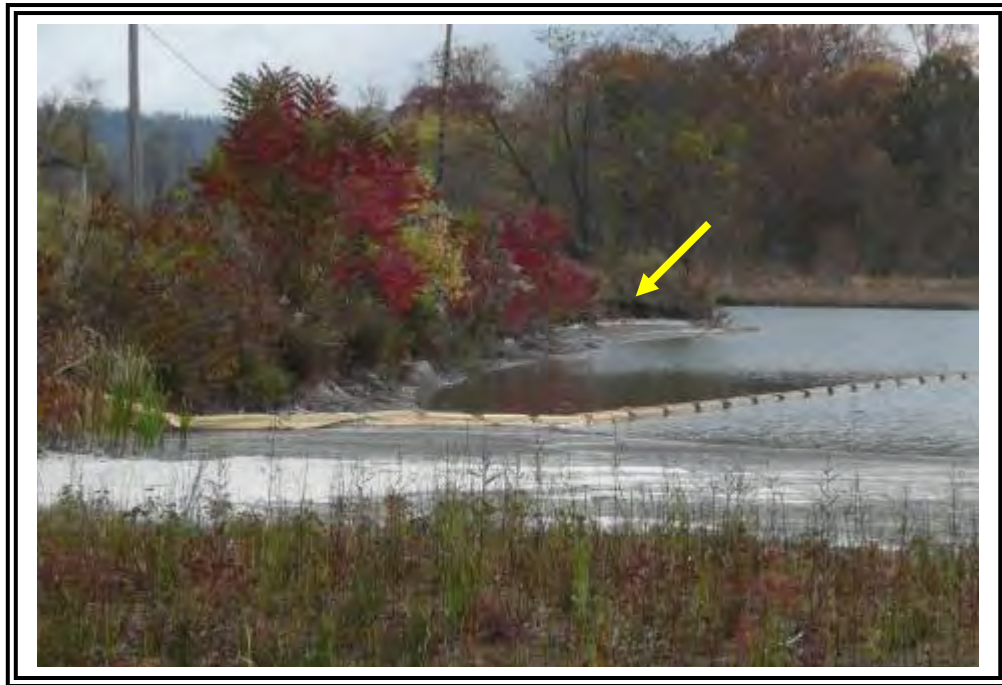
59

Vegetation on north incised wall of Pond 6 and beaching erosion (arrow), looking east.

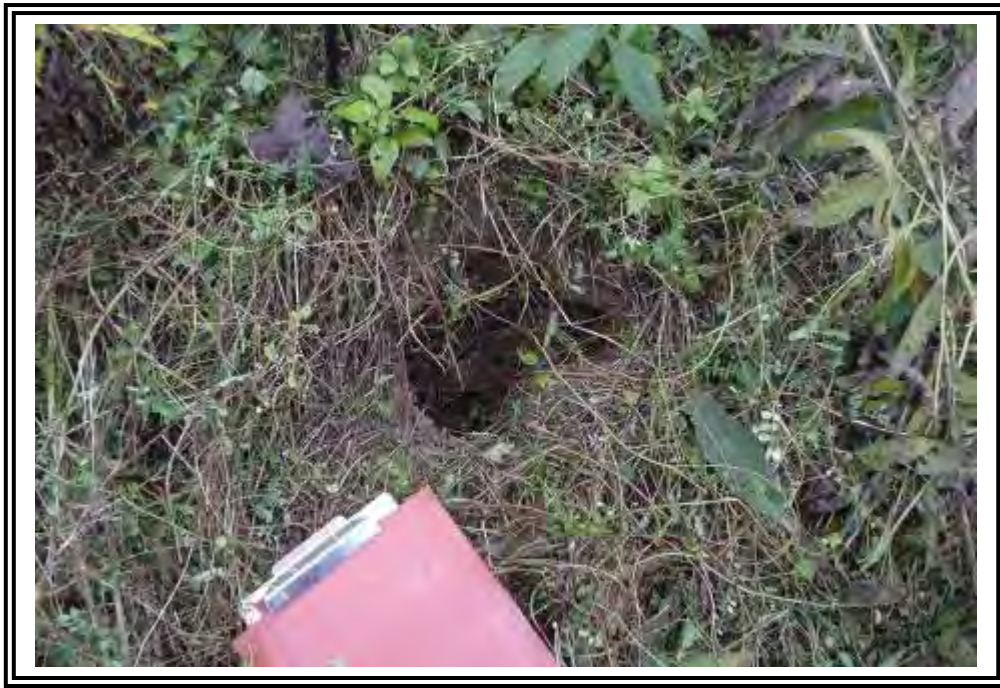
73

Close up of a potentially abandoned rodent hole in the downstream slope of Pond 7/7A east dike.

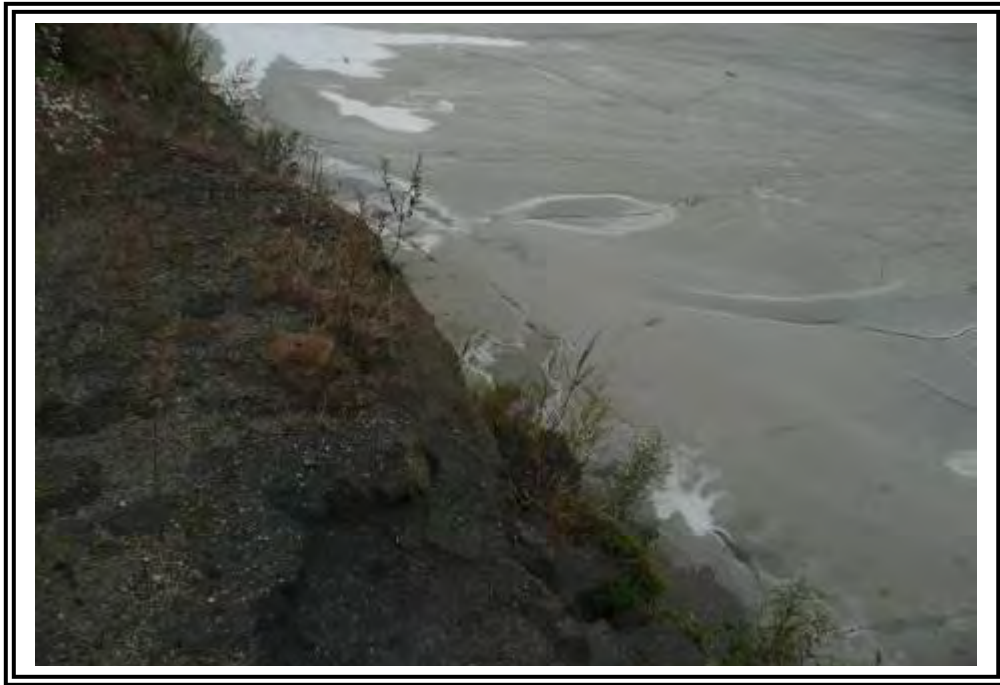
93

Close-up of steep upstream slope and looser material on western dike of Pond 7.

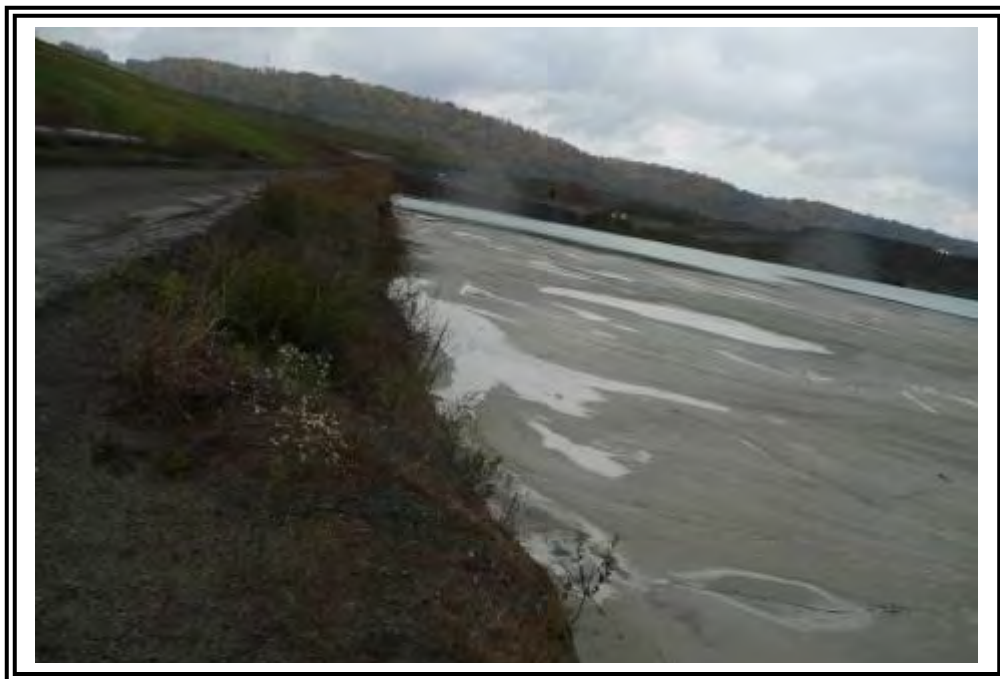
94

The west side of Pond 7 appears to be partially incised, with the crest area functioning as a haul road and foundation for Pond 3A (Photo 94). Grading and routine maintenance activities for the haul road have created a very steep upstream slope subject to sloughing (Photo 93). This combination of steep geometry and loose granular slope surface material has resulted in sparse weedy vegetation and erosion rill formation where runoff is concentrated (Photo 95). Since this pond is presently the active ash basin, an ash delta has formed along the portion of the wall adjacent to where the sluice lines enter at the southwest corner of the pond (Photos 87 and 94).

Looking north along the Pond 7 west dike upstream slope. Note ash delta in pond surface.

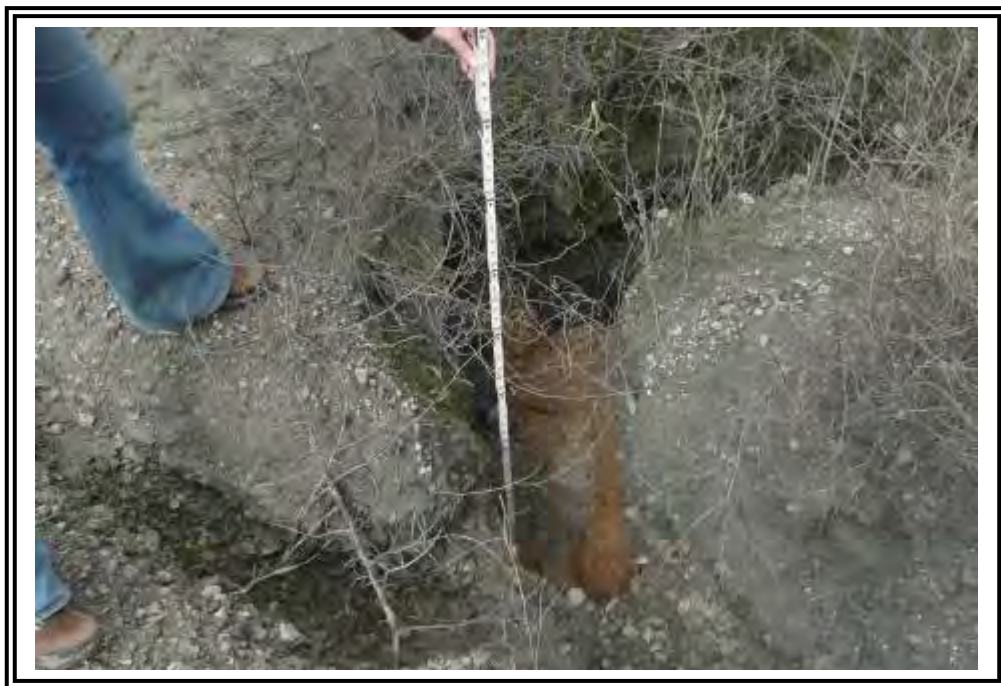
98

Close up of deep erosion rill in the Pond 6 side of the separator dike.

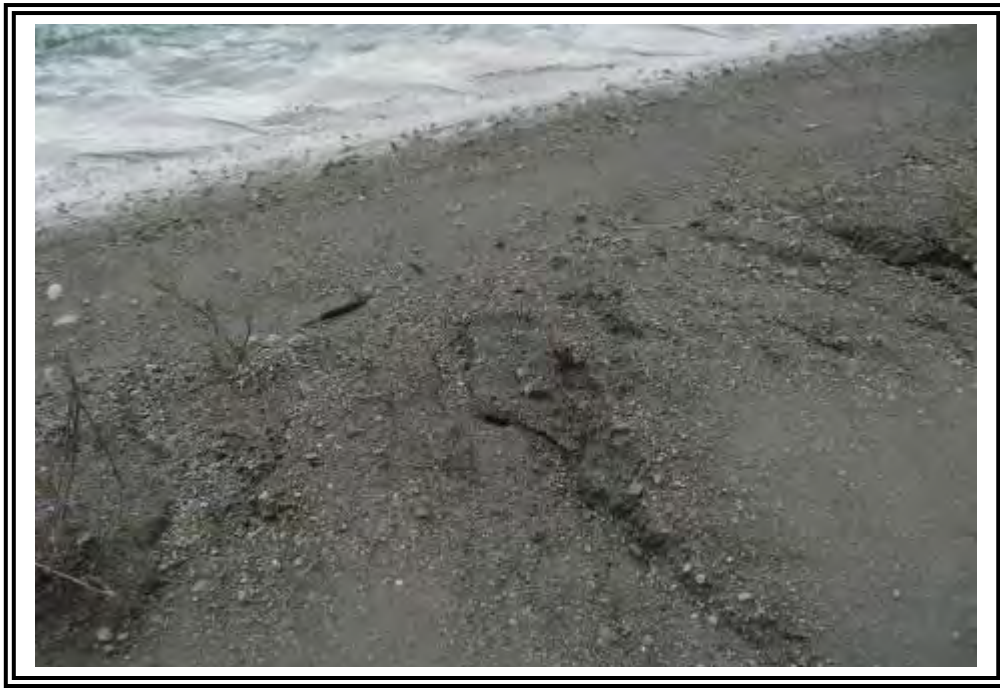
99

The dike separating Pond 6 and Pond 7/7A is a bottom ash and gravel covered dike. As discussed previously, the crest width has increased from 16 feet as initially constructed to roughly 60 feet in some places as a result of grading activities and changes in pond operations. In addition, as material was pushed toward the slopes, they became incrementally steeper and the loose, unconsolidated material at the crest edge became subject to erosion. The deep erosion rills observed on the Pond 6 side of the dike (Photo 98) and the shallower erosion rills on the Pond 7 side (Photo 99) of the dike are evidence of this behavior.

Erosion rills on Pond 7 side of separator dike between Pond 6 and Pond 7/A.

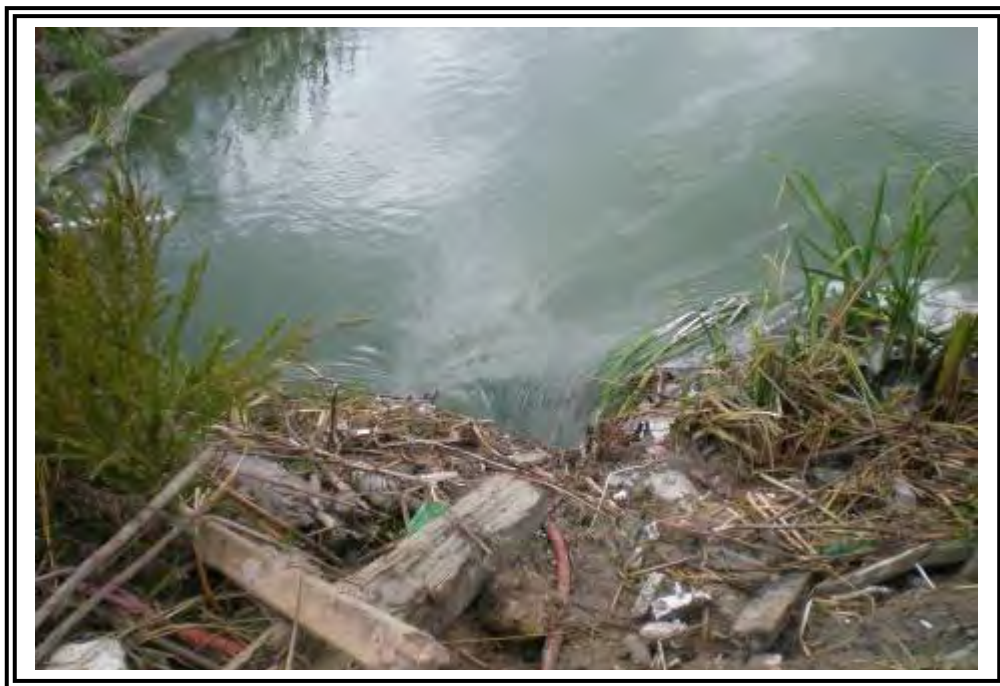
102

Submerged outlet structure for Pond 7 to Pond 6. Note absence of inlet protection.
